## Florida Historical Quarterly

## Excavations from Castillo de San Marcos

CASTILLO DE SAN MARCOS

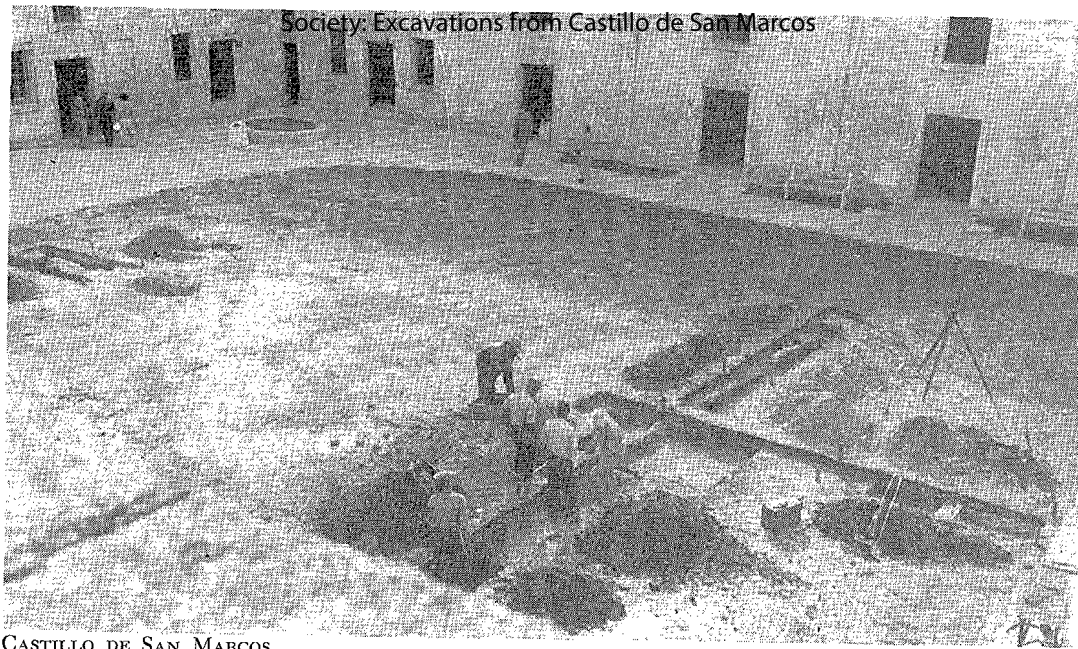
PLATE 1. *This view, looking southwest from the rampart of the Castillo, shows courtyard excavations. Three levels of occupation were found: 1) prehistoric midden, 2) ruins of a 17th century building, and 3) 18th century pavement.*

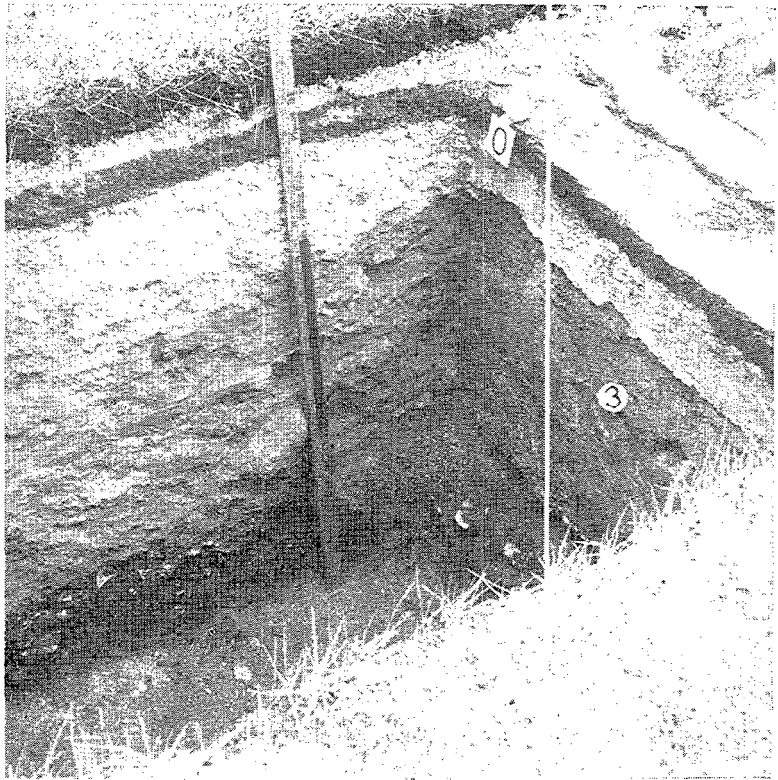
PLATE 2. *Earliest level of occupancy shows in the midden (dark) stratum at the base of this trench. The medium-dark strata above the midden are fill deposited when the masonry wall at right was built (1675). Notice the wavy line of stucco on this wall, which also marks the height of the 1675 fill. The broad, light stratum consists of coquina chippings topped by a tabby masonry pavement which extended over the entire courtyard. It is the result of modernization done in 1738-1739 in preparation for British attack. The narrow strata at top are 20th century deposits.*

*This photograph shows the north end of Trench "A". See Figure 8 for further explanation of the stratigraphy.*
